WHOI-84-30

## A Miniature Urethane Molded Acoustic Transducer

### Technical Report

**Woods Hole Oceanographic Institution  
Woods Hole, Massachusetts 02543**

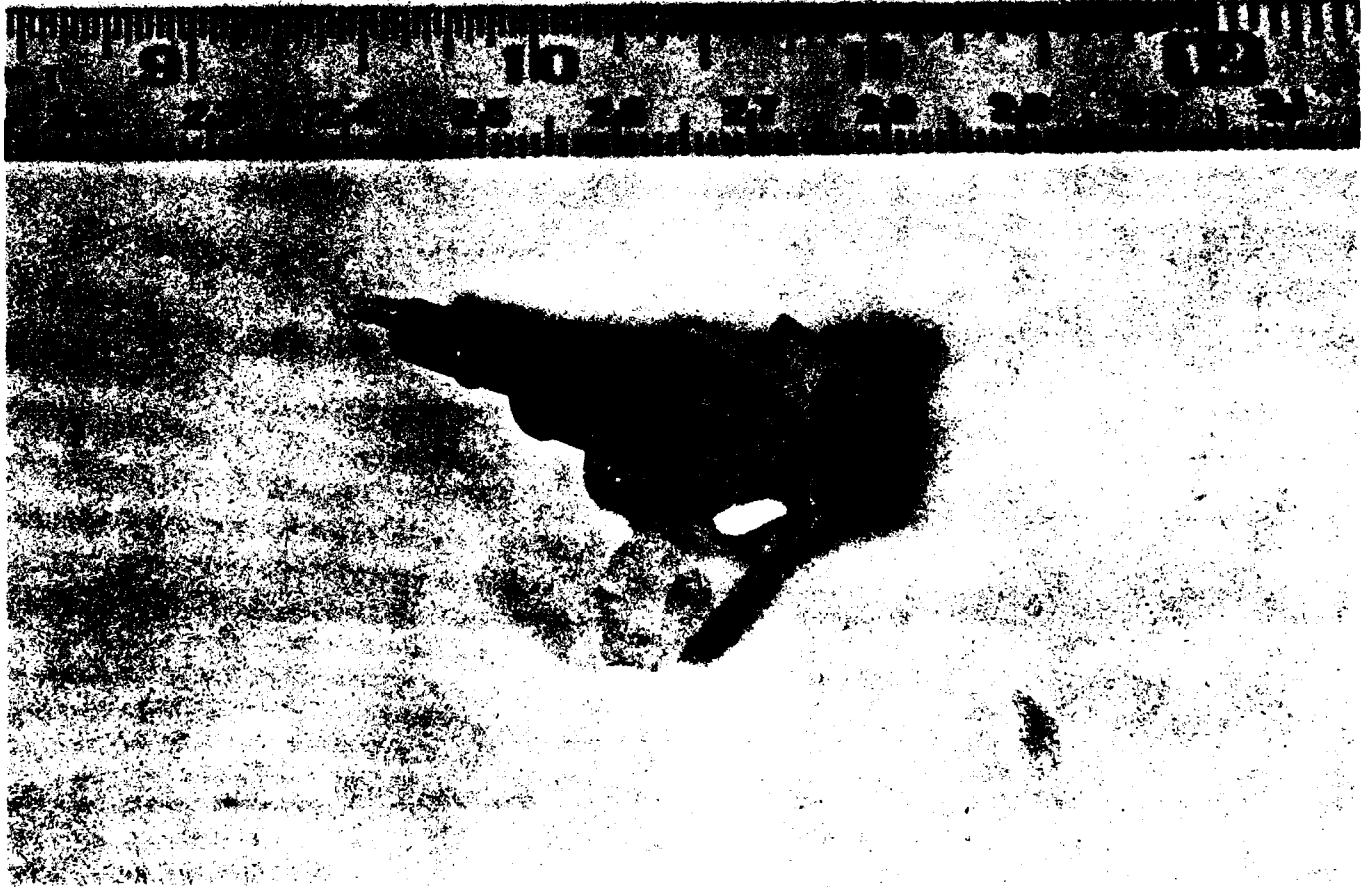
Figure 4.4. Finished Transducer. The finished transducer ready for use. The twisted spring pins, O-ring and convex EN-4 face are visible.

The completed transducers are ready for use (Fig. 4.4).
